# **HAZARDOUS MATERIALS SURVEY REPORT**

## **Eastern State Hospital Building 3**

**4601 Ironbound Rd Williamsburg Virginia 23188**

**Report Date: April 18, 2023**

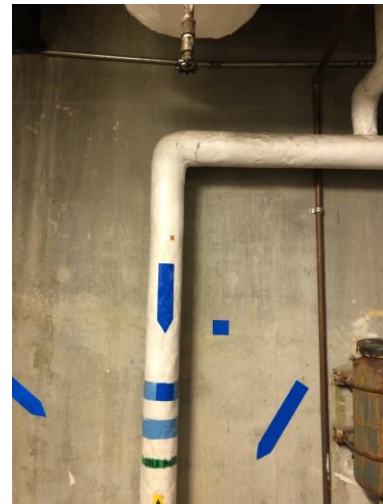
**Sample Numbers:** HFIT-1, HFIT-2, HFIT-3, HFIT - 4  
**Material Description:** Heating Pipe Elbows / Fittings  
**Material Color:** Grey  
**Asbestos Detected:** **Positive**  
**Asbestos Type:** **5% Chrysotile**  
**Homogeneous Area:** Throughout building above ceiling and at baseboards  
**Total Approximate Quantity:** 280 Each  
**Condition:** Good  
**Material Type:** TSI

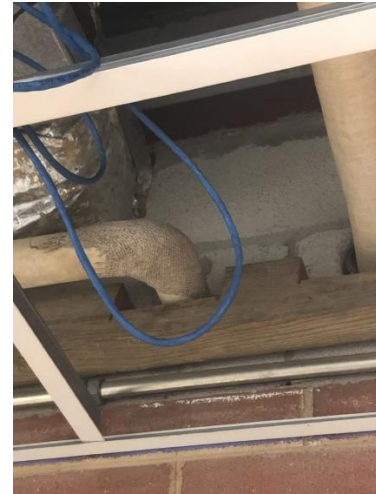
**I.D. Number:** DFIT  
**Material Description:** Domestic Water Pipe Elbows / Fittings  
**Material Color:** White  
**Accessible Material:** Inaccessible  
**Reason Inaccessible:** Behind restroom CMU walls  
**Asbestos Detected:** **Assumed to contain asbestos.**  
**Homogeneous Area:** Restroom Chases throughout building  
**Total Approximate Quantity:** 40 Each  
**Condition:** Fair  
**Material Type:** TSI

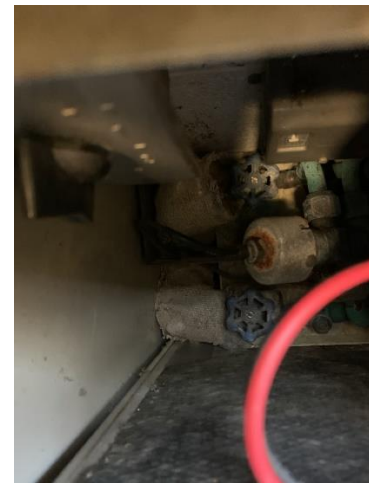
**Sample Numbers:** EC-1, EC-2, EC-3, EC-4  
**Material Description:** Insulation End Cap Sealant  
**Material Color:** Grey, White  
**Asbestos Detected:** None  
**Asbestos Type:** NA  
**Homogeneous Area:** Boiler Area  
**Total Approximate Quantity:** 15 SF  
**Condition:** Poor  
**Material Type:** Misc.

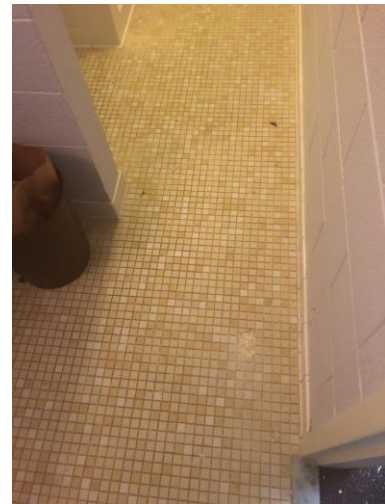
**Sample Numbers:** TG-1, TG-2, TG-3  
**Material Description:** Ceramic Tile Grout  
**Material Color:** White  
**Asbestos Detected:** None  
**Asbestos Type:** NA  
**Homogeneous Area:** Throughout Restrooms  
**Total Approximate Quantity:** 1,800 SF  
**Condition:** Good  
**Material Type:** Misc.

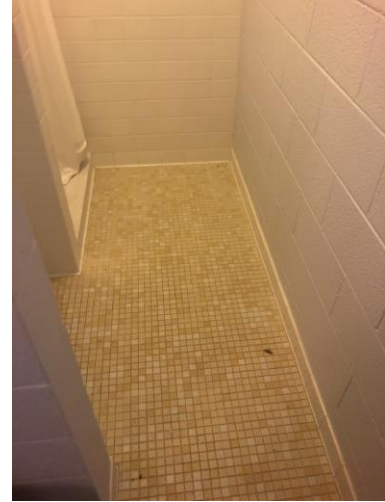
**Sample Numbers:** WTG-1, WTG-2, WTG-3  
**Material Description:** Ceramic Tile and Grout  
**Material Color:** White  
**Asbestos Detected:** None  
**Asbestos Type:** NA  
**Homogeneous Area:** Throughout Restrooms  
**Total Approximate Quantity:** 4,000 SF  
**Condition:** Good  
**Material Type:** Misc.

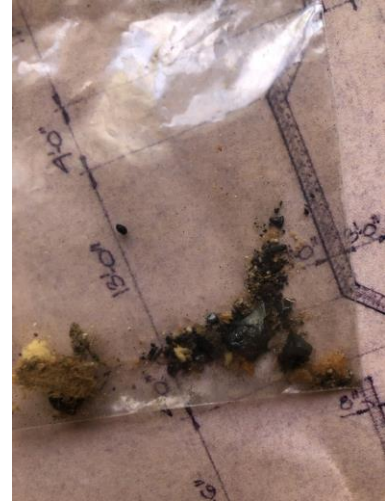
**Sample Numbers:** PL-1, PL-2, PL-3, PL-4  
**Material Description:** Ceiling Plaster  
**Material Color:** White  
**Asbestos Detected:** None  
**Asbestos Type:** NA  
**Homogeneous Area:** Upper Level Restrooms, Foyers, Interior and Exterior Overhangs  
**Total Approximate Quantity:** 1,000 SF  
**Condition:** Good  
**Material Type:** Surfacing

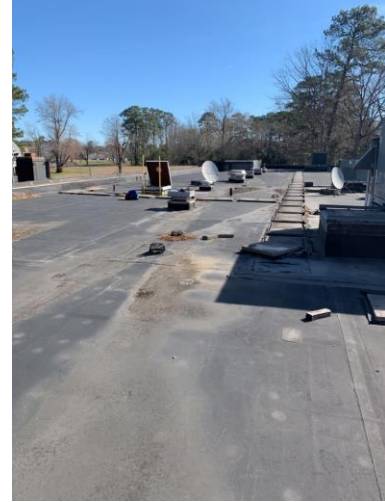
**Sample Numbers:** RFL-2A, RFL-2B, RFL-2C  
**Material Description:** Roof Flashing  
**Material Color:** Black  
**Asbestos Detected:** None  
**Asbestos Type:** NA  
**Homogeneous Area:** Upper Roof  
**Total Approximate Quantity:** 2,400 SF  
**Condition:** Good  
**Material Type:** Misc.

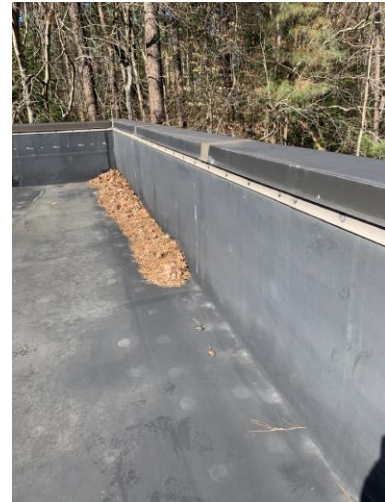
**Sample Numbers:** RSS-3A, RSS-3B, RSS-3C  
**Material Description:** Roof Seam Sealant  
**Material Color:** Black  
**Asbestos Detected:** None  
**Asbestos Type:** NA  
**Homogeneous Area:** Upper and Lower Roofs  
**Total Approximate Quantity:** 800 LF  
**Condition:** Good  
**Material Type:** Misc.

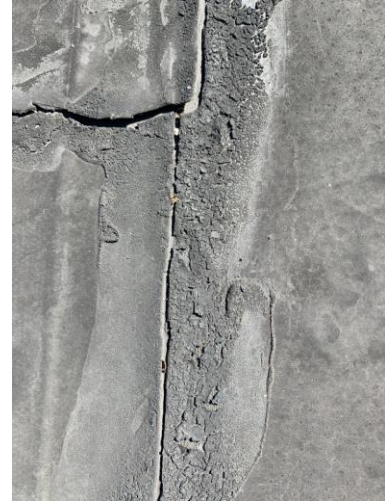
**Sample Numbers:** US-4A, US-4B, US-4C  
**Material Description:** Roof Unit Sealant  
**Material Color:** White  
**Asbestos Detected:** None  
**Asbestos Type:** NA  
**Homogeneous Area:** Upper Roof  
**Total Approximate Quantity:** 250 SF  
**Condition:** Good  
**Material Type:** Misc.

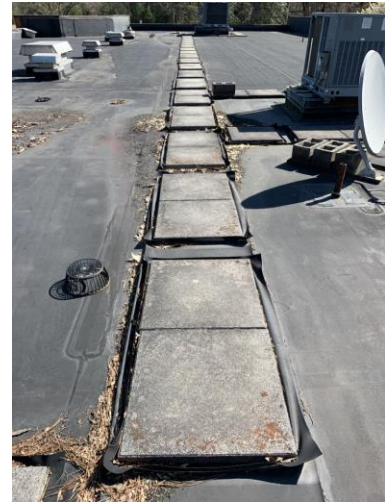
**Sample Numbers:** RF-7A, RF-7B, RF-7C  
**Material Description:** Roof Field  
**Material Color:** Multi-color  
**Asbestos Detected:** None  
**Asbestos Type:** NA  
**Homogeneous Area:** Lower Roof  
**Total Approximate Quantity:** 5,200 SF  
**Condition:** Good  
**Material Type:** Misc.

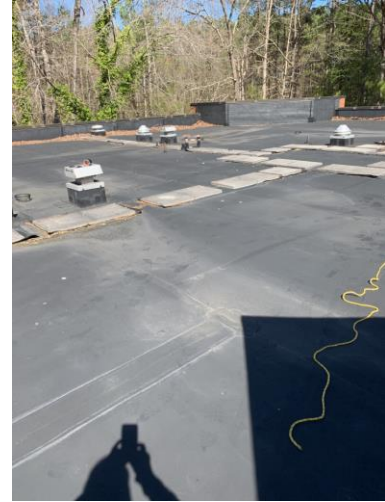
**Sample Numbers:** RFL-8A, RFL-8B, RFL-8C  
**Material Description:** Roof Flashing  
**Material Color:** Black  
**Asbestos Detected:** None  
**Asbestos Type:** NA  
**Homogeneous Area:** Lower Roof  
**Total Approximate Quantity:** 1,000 SF  
**Condition:** Good  
**Material Type:** Misc.

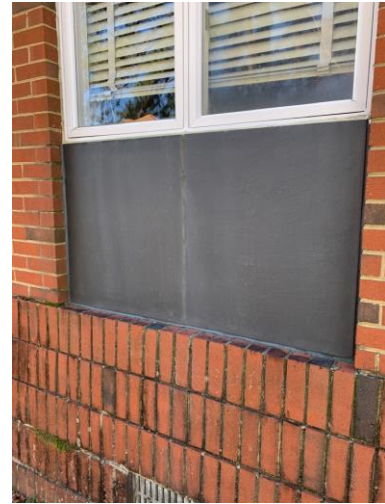
**Sample Numbers:** PCLK-2A, PCLK-2B, PCLK-2C  
**Material Description:** Window Panel Caulk  
**Material Color:** Black  
**Asbestos Detected:** None  
**Asbestos Type:** NA  
**Homogeneous Area:** Building Exterior  
**Total Approximate Quantity:** 1,000 LF  
**Condition:** Good  
**Material Type:** Misc.

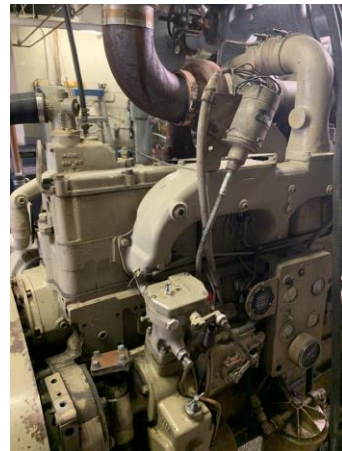
**XRF Reading:** 4  
**Component:** Generator Belt Casing  
**Substrate:** Metal  
**Paint Coating Condition:** Intact  
**Color:** Green  
**Sample Location:** Boiler Room  
**Below Reportable Limit:** no  
**XRF Result (mg/cm<sup>2</sup>):** 0.02  
**Paint Classification:** LCP

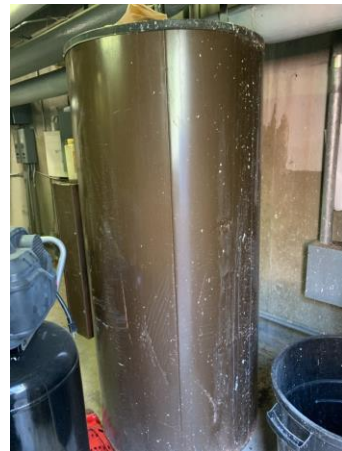
**XRF Reading:** 7  
**Component:** Water Heater Casing  
**Substrate:** Metal  
**Paint Coating Condition:** Intact  
**Color:** Gray  
**Sample Location:** Boiler Room  
**Below Reportable Limit:** yes  
**XRF Result (mg/cm<sup>2</sup>):** ND

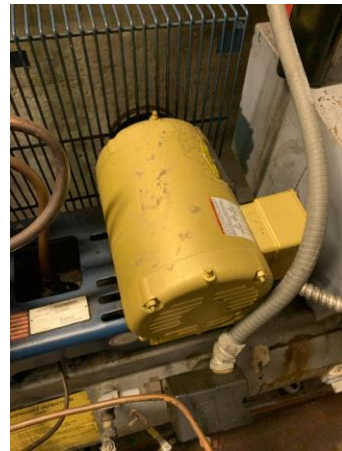
**XRF Reading: 13**  
**Component:** Air Compressor  
**Substrate:** Steel  
**Paint Coating Condition:** Intact  
**Color:** Blue  
**Sample Location:** Oil Well  
**Below Reportable Limit:** yes  
**XRF Result (mg/cm<sup>2</sup>):** ND

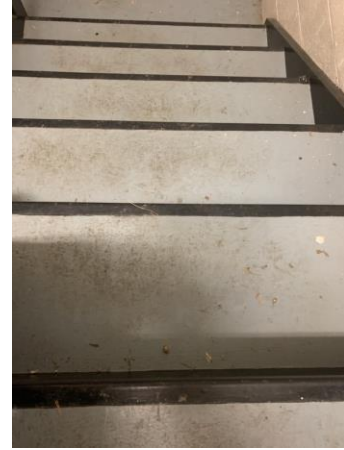
**XRF Reading:** 36  
**Component:** Stair Riser  
**Substrate:** Steel  
**Paint Coating Condition:** Intact  
**Color:** Black  
**Sample Location:** Lower Section North  
**Below Reportable Limit:** no  
**XRF Result (mg/cm<sup>2</sup>):** 3.0  
**Paint Classification:** **LBP**

OSHA does not set a minimum threshold concentration defining lead content in paint. Any paint with a concentration greater than zero is considered to be lead containing, and certain requirements of the OSHA standard 29 CFR 1926.62 are applicable. As previously noted, thirty-one (31) of the seventy-seven (77) XRF tested painted/coated surfaces had detectable concentrations of lead. If the painted surfaces are to be impacted during renovation and/or demolition activities the following precautions are recommended:

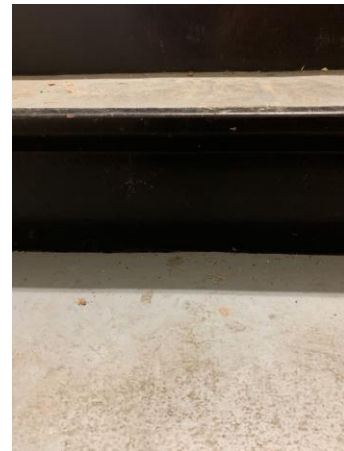
**XRF Reading:** 37  
**Component:** Stair Stringer  
**Substrate:** Steel  
**Paint Coating Condition:** Intact  
**Color:** Black  
**Sample Location:** Lower Level North  
**Below Reportable Limit:** no  
**XRF Result (mg/cm<sup>2</sup>):** 5.0  
**Paint Classification:** **LBP**

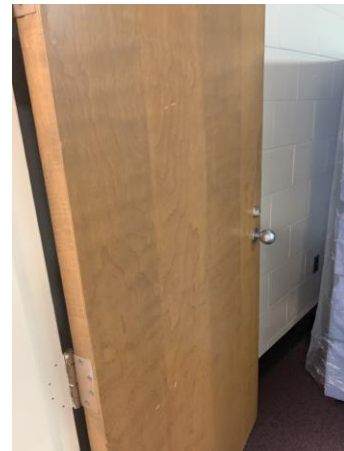
**XRF Reading:** 40  
**Component:** Door Jamb  
**Substrate:** Metal  
**Paint Coating Condition:** Intact  
**Color:** White  
**Sample Location:** Lower Level East  
**Below Reportable Limit:** no  
**XRF Result (mg/cm<sup>2</sup>):** 0.016  
**Paint Classification:** LCP
