# **HAZARDOUS MATERIALS SURVEY REPORT**

## **Eastern State Hospital Building 3**

**4601 Ironbound Rd Williamsburg Virginia 23188**

**Report Date: April 18, 2023**

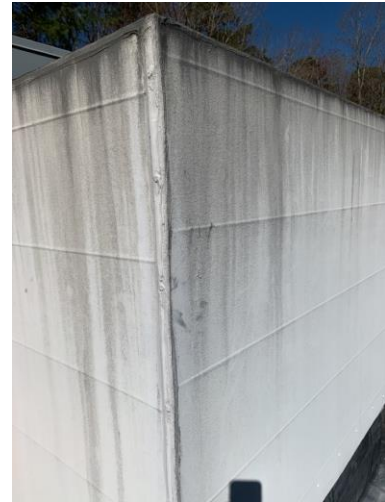
**Sample Numbers:** VC-5A, VC-5B, VC-5C

**Material Description:** Roof Vent Caulk

**Condition:** Good

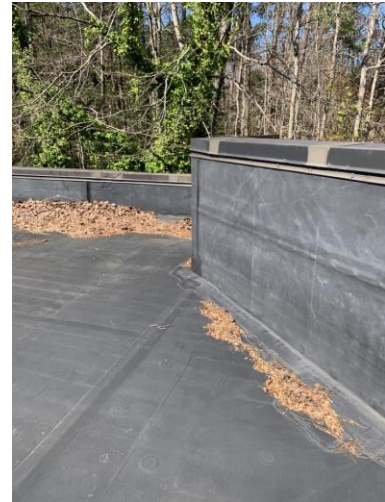
**Sample Numbers:** VC-9A, VC-9B, VC-9C

**Material Description:** Roof Vent Caulk

**Condition:** Damaged

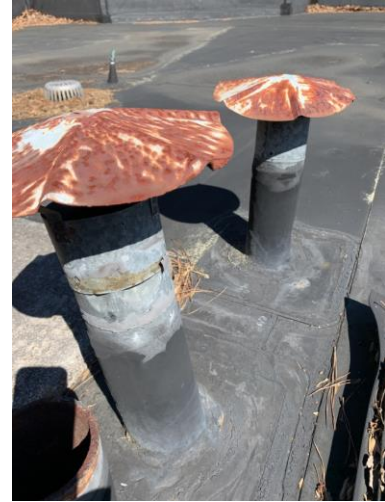
**Sample Numbers:** VC-10A, VC-10B, VC-10C

**Material Description:** Roof Vent Caulk

**Condition:** Good

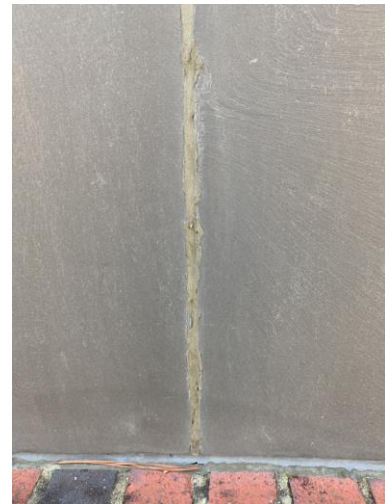
**Sample Numbers:** WCLK-3A, WCLK-3B, WCLK-3C

**Material Description:** Window Caulk

**Condition:** Good

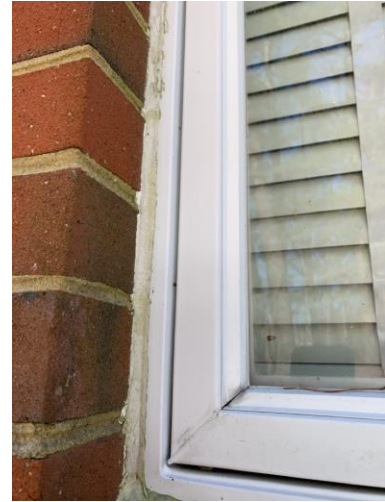
**Sample Numbers:** DCLK-4A, DCLK-4B, DCLK-4C

**Material Description:** Exterior Door Caulk

**Condition:** Good

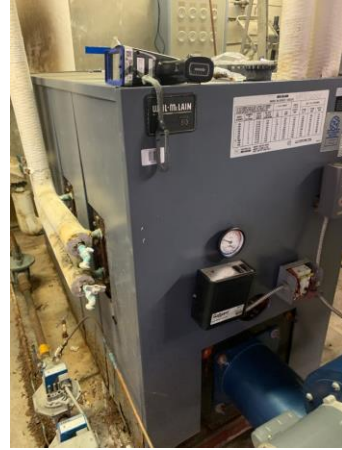
**XRF Reading:** 2  
**Component:** Boiler casing  
**Substrate:** Metal  
**Paint Coating Condition:** Intact  
**Color:** Gray  
**Sample Location:** Boiler Room  
**Below Reportable Limit:** yes  
**XRF Result (mg/cm<sup>2</sup>):** ND

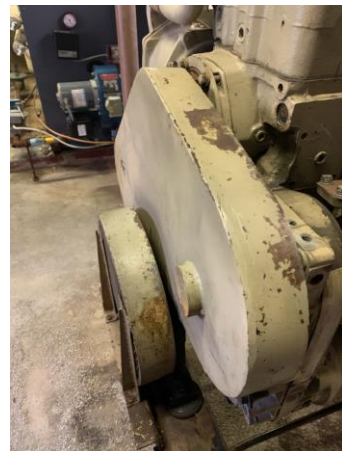
**XRF Reading:** 4  
**Component:** Generator Belt Casing  
**Substrate:** Metal  
**Paint Coating Condition:** Intact  
**Color:** Green  
**Sample Location:** Boiler Room  
**Below Reportable Limit:** no  
**XRF Result (mg/cm<sup>2</sup>):** 0.02  
**Paint Classification:** LCP

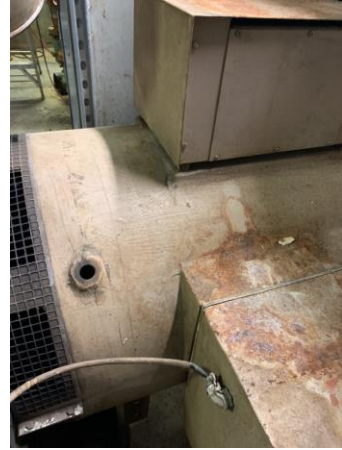
**XRF Reading:** 5  
**Component:** Generator Fan Casing  
**Substrate:** Metal  
**Paint Coating Condition:** Intact  
**Color:** Tan  
**Sample Location:** Boiler Room  
**Below Reportable Limit:** no  
**XRF Result (mg/cm<sup>2</sup>):** 0.004  
**Paint Classification:** **LCP**

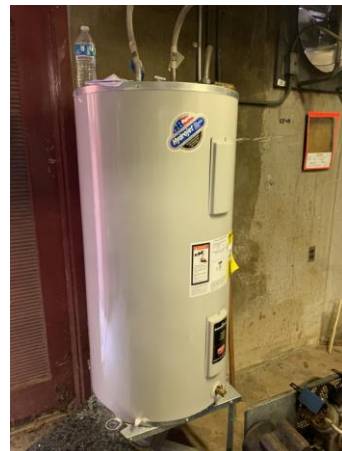
**XRF Reading:** 7  
**Component:** Water Heater Casing  
**Substrate:** Metal  
**Paint Coating Condition:** Intact  
**Color:** Gray  
**Sample Location:** Boiler Room  
**Below Reportable Limit:** yes  
**XRF Result (mg/cm<sup>2</sup>):** ND

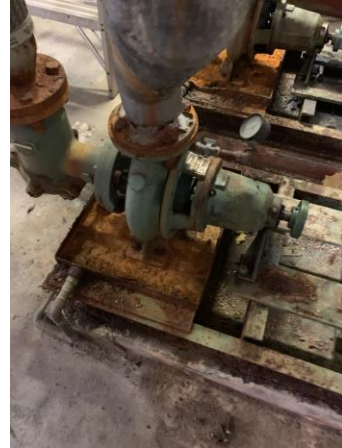
**XRF Reading:** 8  
**Component:** Circulating Pump  
**Substrate:** Steel  
**Paint Coating Condition:** Intact  
**Color:** Gray  
**Sample Location:** Pump  
**Below Reportable Limit:** no  
**XRF Result (mg/cm<sup>2</sup>):** 0.012  
**Paint Classification:** LCP

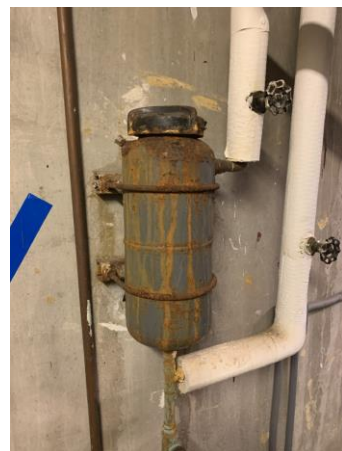
**XRF Reading:** 10  
**Component:** Flash Tank  
**Substrate:** Steel  
**Paint Coating Condition:** Fair  
**Color:** Gray  
**Sample Location:** Tank Casing  
**Below Reportable Limit:** yes  
**XRF Result (mg/cm<sup>2</sup>):** ND

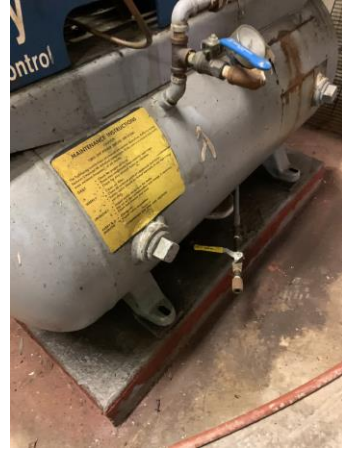
**XRF Reading: 11**  
**Component:** Air Compressor  
**Substrate:** Steel  
**Paint Coating Condition:** Intact  
**Color:** Gray  
**Sample Location:** Tank  
**Below Reportable Limit:** no  
**XRF Result (mg/cm<sup>2</sup>):** 0.11  
**Paint Classification:** **LCP**

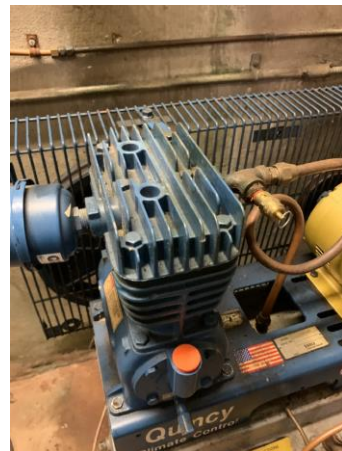
**XRF Reading: 13**  
**Component:** Air Compressor  
**Substrate:** Steel  
**Paint Coating Condition:** Intact  
**Color:** Blue  
**Sample Location:** Oil Well  
**Below Reportable Limit:** yes  
**XRF Result (mg/cm<sup>2</sup>):** ND

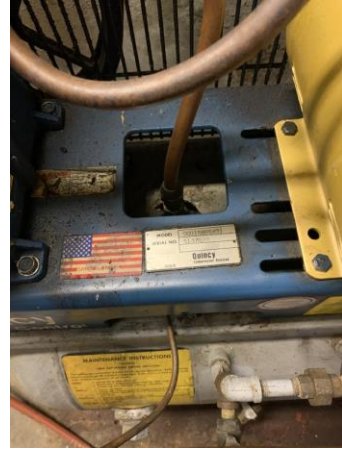
**XRF Reading:** 14  
**Component:** Air Compressor  
**Substrate:** Metal  
**Paint Coating Condition:** Intact  
**Color:** Blue  
**Sample Location:** Compressor Mount  
**Below Reportable Limit:** yes  
**XRF Result (mg/cm<sup>2</sup>):** ND

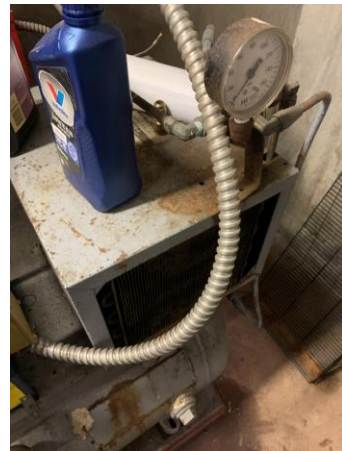
**XRF Reading:** 15  
**Component:** Air Compressor  
**Substrate:** Metal  
**Paint Coating Condition:** Intact  
**Color:** Gray  
**Sample Location:** Filter Cover  
**Below Reportable Limit:** no  
**XRF Result (mg/cm<sup>2</sup>):** 0.05  
**Paint Classification:** LCP

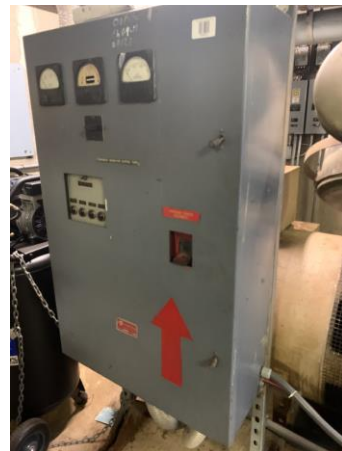
**XRF Reading:** 16  
**Component:** Electrical Box  
**Substrate:** Metal  
**Paint Coating Condition:** Intact  
**Color:** Gray  
**Sample Location:** Casing  
**Below Reportable Limit:** yes  
**XRF Result (mg/cm<sup>2</sup>):** ND

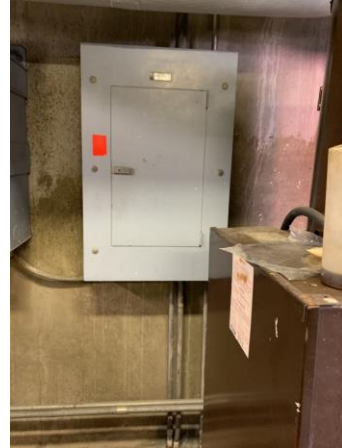
**XRF Reading:** 17  
**Component:** Electrical Box  
**Substrate:** Metal  
**Paint Coating Condition:** Intact  
**Color:** Light Gray  
**Sample Location:** Casing  
**Below Reportable Limit:** no  
**XRF Result (mg/cm<sup>2</sup>):** 0.01  
**Paint Classification:** **LCP**

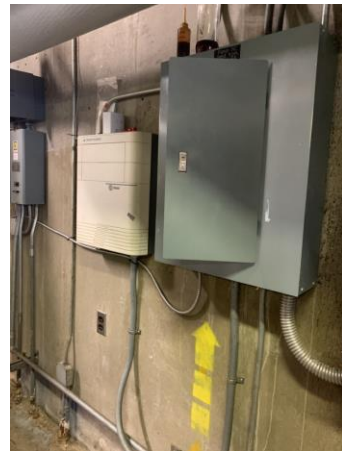
**XRF Reading:** 18  
**Component:** Electrical Panel  
**Substrate:** Metal  
**Paint Coating Condition:** Intact  
**Color:** Gray  
**Sample Location:** Casing  
**Below Reportable Limit:** yes  
**XRF Result (mg/cm<sup>2</sup>):** ND

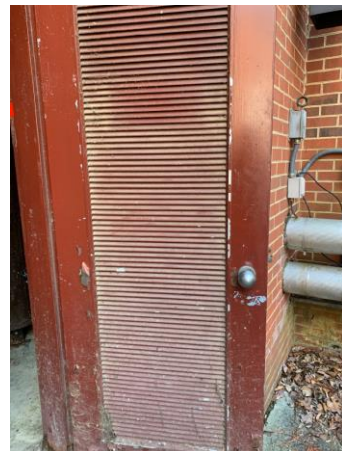
**XRF Reading:** 19  
**Component:** Door  
**Substrate:** Metal  
**Paint Coating Condition:** Poor  
**Color:** Red  
**Sample Location:** Boiler Room Door  
**Below Reportable Limit:** no  
**XRF Result (mg/cm<sup>2</sup>):** 0.02  
**Paint Classification:** **LCP**

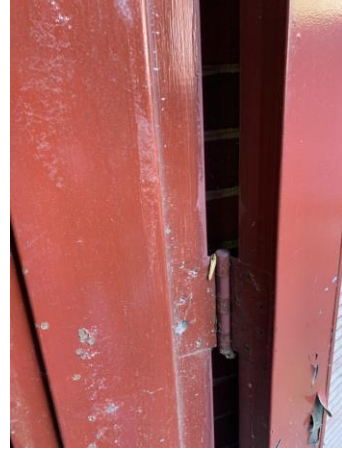
**XRF Reading:** 20  
**Component:** Door Jam  
**Substrate:** Metal  
**Paint Coating Condition:** Poor  
**Color:** Red  
**Sample Location:** Boiler Room Door Jamb  
**Below Reportable Limit:** no  
**XRF Result (mg/cm<sup>2</sup>):** 0.02  
**Paint Classification:** **LCP**

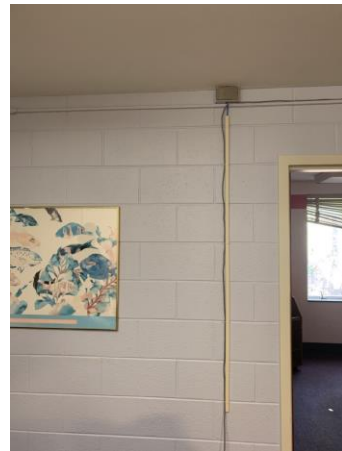
**XRF Reading:** 21  
**Component:** Wall  
**Substrate:** CMU  
**Paint Coating Condition:** Intact  
**Color:** Light Blue  
**Sample Location:** Lower Level North  
**Below Reportable Limit:** yes  
**XRF Result (mg/cm<sup>2</sup>):** ND

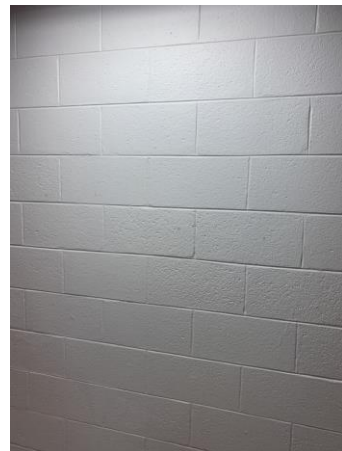
**XRF Reading:** 22  
**Component:** Wall  
**Substrate:** CMU  
**Paint Coating Condition:** Intact  
**Color:** White  
**Sample Location:** Lower Level North  
**Below Reportable Limit:** yes  
**XRF Result (mg/cm<sup>2</sup>):** ND

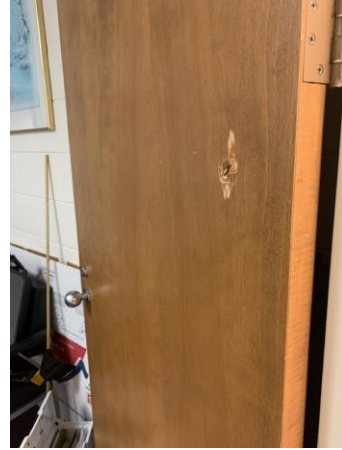
**XRF Reading:** 23  
**Component:** Door  
**Substrate:** Wood  
**Paint Coating Condition:** Intact  
**Color:** Varnish  
**Sample Location:** Lower Level North  
**Below Reportable Limit:** yes  
**XRF Result (mg/cm<sup>2</sup>):** ND

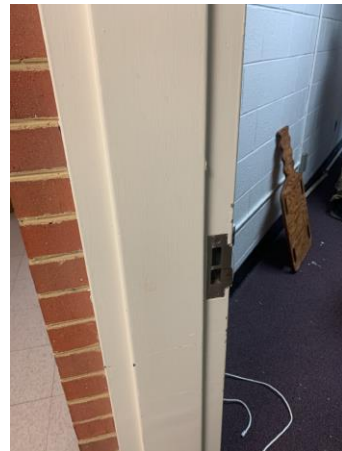
**XRF Reading:** 24  
**Component:** Door Jamb  
**Substrate:** Metal  
**Paint Coating Condition:** Intact  
**Color:** Beige  
**Sample Location:** Lower Level North  
**Below Reportable Limit:** yes  
**XRF Result (mg/cm<sup>2</sup>):** ND

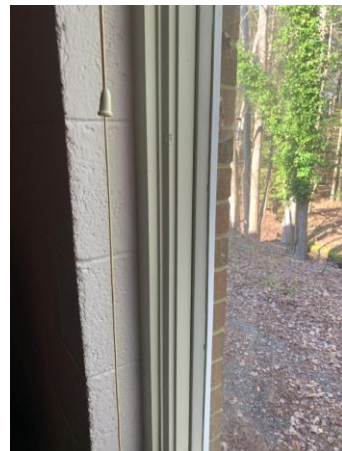
**XRF Reading:** 25  
**Component:** Window Casing  
**Substrate:** Wood  
**Paint Coating Condition:** Intact  
**Color:** Beige  
**Sample Location:** Lower Level North  
**Below Reportable Limit:** no  
**XRF Result (mg/cm<sup>2</sup>):** 0.019  
**Paint Classification:** LCP

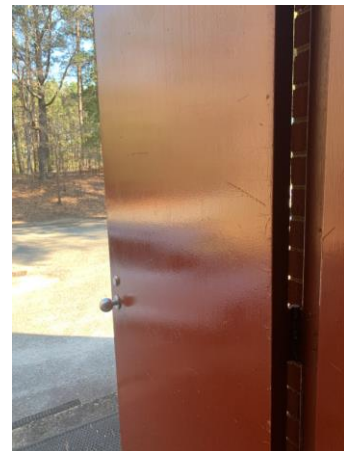
**XRF Reading:** 28  
**Component:** Door  
**Substrate:** Metal  
**Paint Coating Condition:** Intact  
**Color:** Red  
**Sample Location:** Lower Level North  
**Below Reportable Limit:** no  
**XRF Result (mg/cm<sup>2</sup>):** 0.027  
**Paint Classification:** LCP

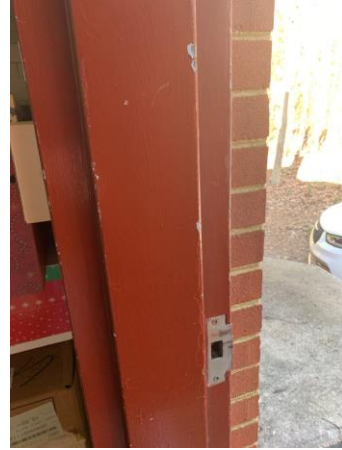
**XRF Reading:** 29  
**Component:** Door Jamb  
**Substrate:** Metal  
**Paint Coating Condition:** Intact  
**Color:** Red  
**Sample Location:** Lower Level North  
**Below Reportable Limit:** no  
**XRF Result (mg/cm<sup>2</sup>):** 0.02  
**Paint Classification:** LCP

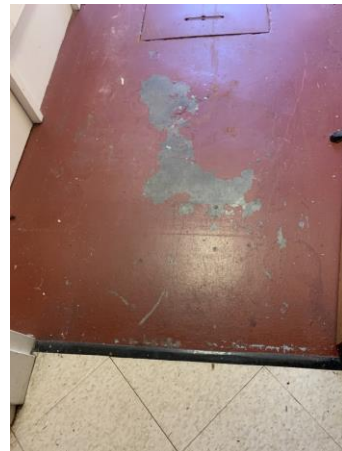
**XRF Reading:** 30  
**Component:** Floor  
**Substrate:** Concrete  
**Paint Coating Condition:** Fair  
**Color:** Red  
**Sample Location:** Lower Section North  
**Below Reportable Limit:** yes  
**XRF Result (mg/cm<sup>2</sup>):** ND

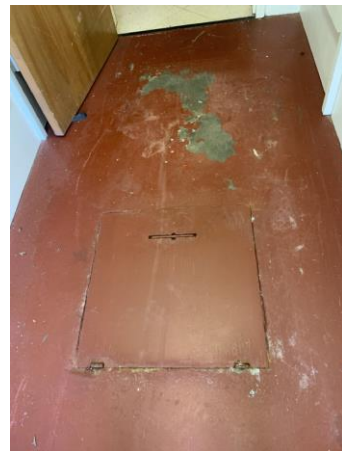
**XRF Reading:** 31  
**Component:** Floor Hatch  
**Substrate:** Steel  
**Paint Coating Condition:** Intact  
**Color:** Red  
**Sample Location:** Lower Level North  
**Below Reportable Limit:** yes  
**XRF Result (mg/cm<sup>2</sup>):** ND

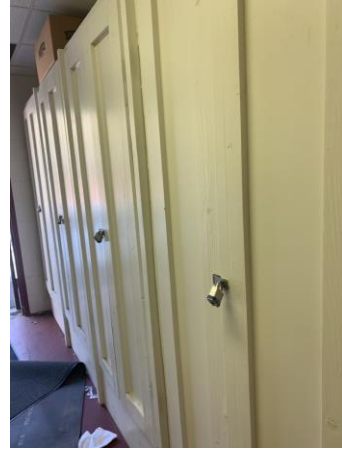
**XRF Reading:** 32  
**Component:** Closet  
**Substrate:** Wood  
**Paint Coating Condition:** Intact  
**Color:** White  
**Sample Location:** Lower Section North  
**Below Reportable Limit:** yes  
**XRF Result (mg/cm<sup>2</sup>):** ND

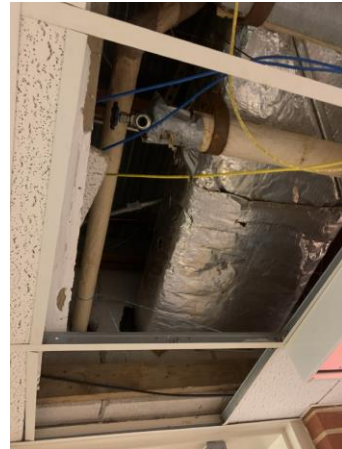
**XRF Reading:** 33  
**Component:** Ceiling Grid  
**Substrate:** Metal  
**Paint Coating Condition:** Intact  
**Color:** Beige  
**Sample Location:** Lower Level North  
**Below Reportable Limit:** yes  
**XRF Result (mg/cm<sup>2</sup>):** ND

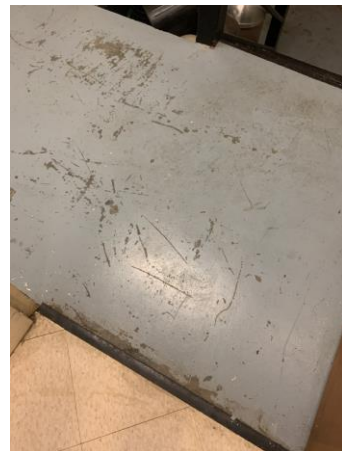
**XRF Reading:** 34  
**Component:** Floor  
**Substrate:** Concrete  
**Paint Coating Condition:** Fair  
**Color:** Gray  
**Sample Location:** Lower Level North  
**Below Reportable Limit:** no  
**XRF Result (mg/cm<sup>2</sup>):** 0.009  
**Paint Classification:** LCP

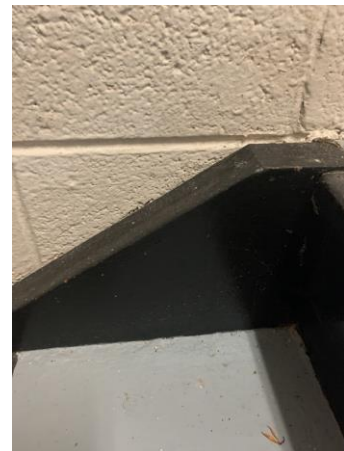
**XRF Reading:** 37  
**Component:** Stair Stringer  
**Substrate:** Steel  
**Paint Coating Condition:** Intact  
**Color:** Black  
**Sample Location:** Lower Level North  
**Below Reportable Limit:** no  
**XRF Result (mg/cm<sup>2</sup>):** 5.0  
**Paint Classification:** **LBP**

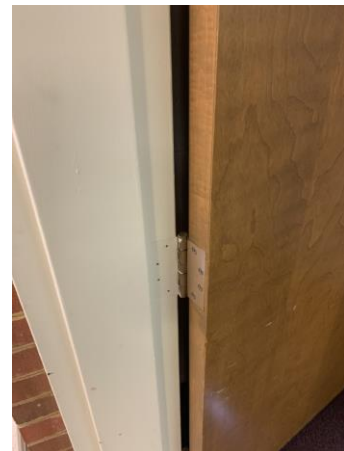
**XRF Reading:** 40  
**Component:** Door Jamb  
**Substrate:** Metal  
**Paint Coating Condition:** Intact  
**Color:** White  
**Sample Location:** Lower Level East  
**Below Reportable Limit:** no  
**XRF Result (mg/cm<sup>2</sup>):** 0.016  
**Paint Classification:** LCP

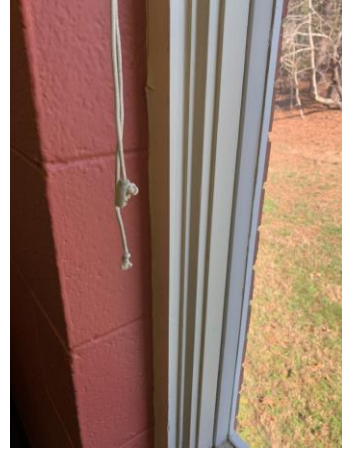
**XRF Reading:** 41  
**Component:** Window Casing  
**Substrate:** Wood  
**Paint Coating Condition:** Intact  
**Color:** White  
**Sample Location:** Lower Level East  
**Below Reportable Limit:** no  
**XRF Result (mg/cm<sup>2</sup>):** 0.01  
**Paint Classification:** LCP

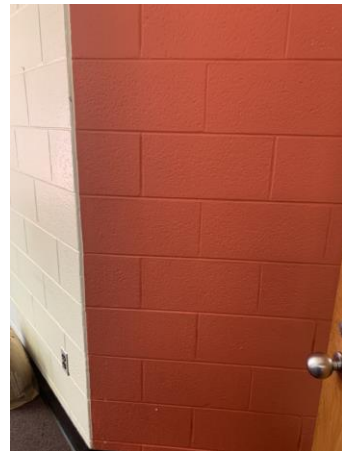
**XRF Reading:** 42  
**Component:** Wall  
**Substrate:** CMU  
**Paint Coating Condition:** Intact  
**Color:** Orange  
**Sample Location:** Lower Level East  
**Below Reportable Limit:** yes  
**XRF Result (mg/cm<sup>2</sup>):** ND

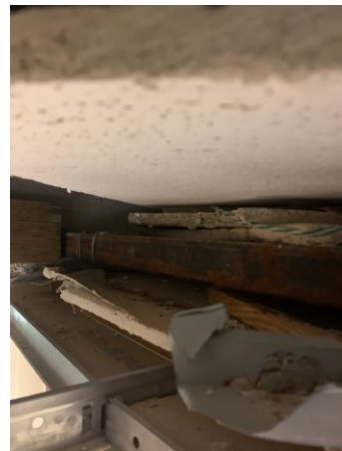
**XRF Reading:** 43  
**Component:** Ceiling Black Iron  
**Substrate:** Metal  
**Paint Coating Condition:** Fair  
**Color:** Black  
**Sample Location:** Lower Level East  
**Below Reportable Limit:** yes  
**XRF Result (mg/cm<sup>2</sup>):** ND

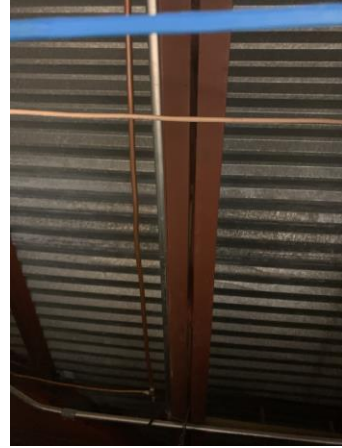
**XRF Reading:** 44  
**Component:** Structural Steel Beam  
**Substrate:** Steel  
**Paint Coating Condition:** Intact  
**Color:** Red  
**Sample Location:** Lower Level East  
**Below Reportable Limit:** yes  
**XRF Result (mg/cm<sup>2</sup>):** ND

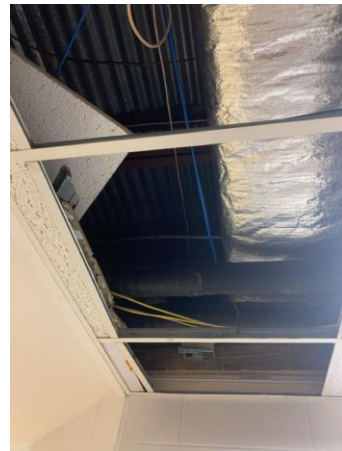
**XRF Reading:** 45  
**Component:** Ceiling Grid  
**Substrate:** Metal  
**Paint Coating Condition:** Intact  
**Color:** White  
**Sample Location:** Lower Level East  
**Below Reportable Limit:** yes  
**XRF Result (mg/cm<sup>2</sup>):** ND

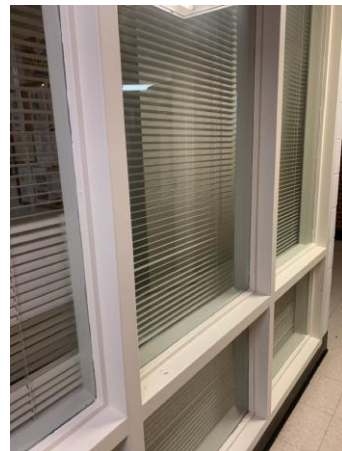
**XRF Reading:** 4  
**Component:** Window Casing  
**Substrate:** Metal  
**Paint Coating Condition:** Intact  
**Color:** White  
**Sample Location:** Lower Level West  
**Below Reportable Limit:** yes  
**XRF Result (mg/cm<sup>2</sup>):** ND

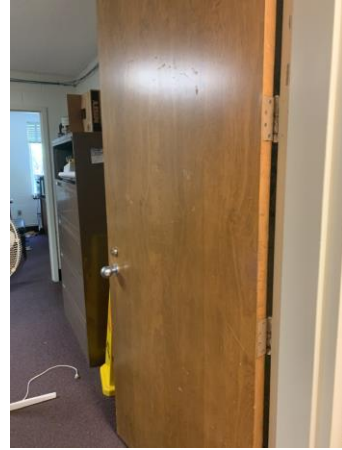
**XRF Reading:** 47  
**Component:** Door  
**Substrate:** Wood  
**Paint Coating Condition:** Intact  
**Color:** Varnish  
**Sample Location:** Lower Level West  
**Below Reportable Limit:** yes  
**XRF Result (mg/cm<sup>2</sup>):** ND

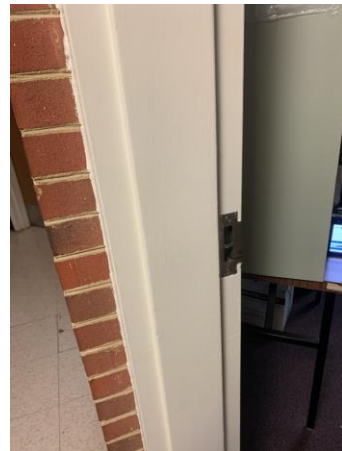
**XRF Reading:** 48  
**Component:** Door Jamb  
**Substrate:** Metal  
**Paint Coating Condition:** Intact  
**Color:** White  
**Sample Location:** Lower Level West  
**Below Reportable Limit:** no  
**XRF Result (mg/cm<sup>2</sup>):** 0.008  
**Paint Classification:** LCP

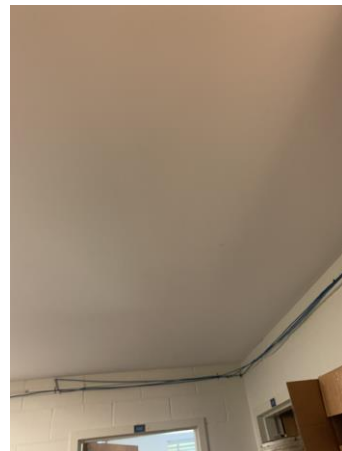
**XRF Reading:** 49  
**Component:** Ceiling  
**Substrate:** Drywall  
**Paint Coating Condition:** Intact  
**Color:** White  
**Sample Location:** Lower Level West  
**Below Reportable Limit:** yes  
**XRF Result (mg/cm<sup>2</sup>):** ND

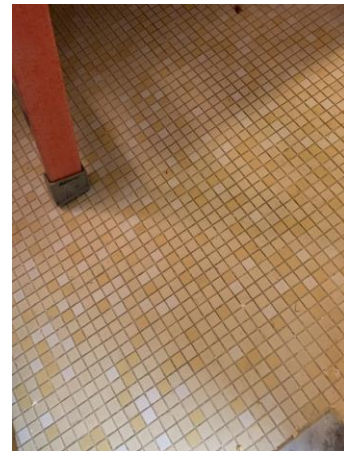
**XRF Reading:** 51  
**Component:** Floor  
**Substrate:** Ceramic Tile  
**Glaze Coating Condition:** Intact  
**Color:** Orange  
**Sample Location:** Lower Level North  
**Below Reportable Limit:** yes  
**XRF Result (mg/cm<sup>2</sup>):** ND

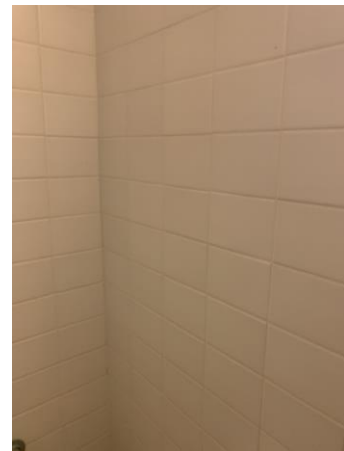
**XRF Reading:** 52  
**Component:** Wall  
**Substrate:** Ceramic Tile  
**Glaze Coating Condition:** Intact  
**Color:** Light Blue  
**Sample Location:** Lower Level North  
**Below Reportable Limit:** no  
**XRF Result (mg/cm<sup>2</sup>):** 0.007  
**Coating Classification:** LCP

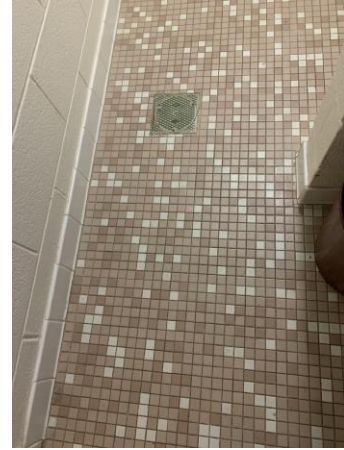
**XRF Reading:** 53  
**Component:** Floor  
**Substrate:** Ceramic Tile  
**Glaze Coating Condition:** Intact  
**Color:** Tan  
**Sample Location:** Lower Level East  
**Below Reportable Limit:** yes  
**XRF Result (mg/cm<sup>2</sup>):** ND

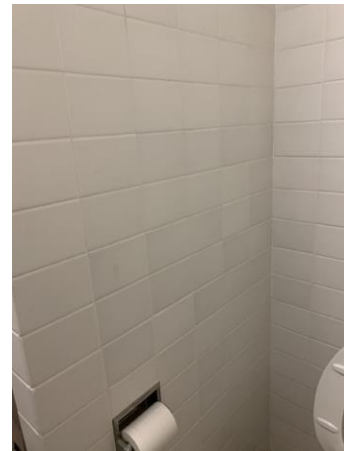
**XRF Reading:** 54  
**Component:** Wall  
**Substrate:** Ceramic Tile  
**Glaze Coating Condition:** Intact  
**Color:** Light Blue  
**Sample Location:** Lower Level East  
**Below Reportable Limit:** no  
**XRF Result (mg/cm<sup>2</sup>):** 0.016  
**Glaze Classification:** LCP

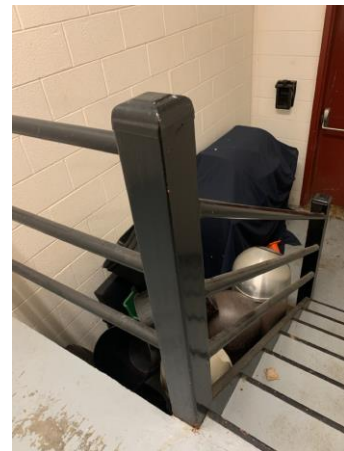
**XRF Reading:** 55  
**Component:** Stair Hand Rail Post  
**Substrate:** Steel  
**Paint Coating Condition:** Intact  
**Color:** Black  
**Sample Location:** Lower Level North  
**Below Reportable Limit:** no  
**XRF Result (mg/cm<sup>2</sup>):** 5.0  
**Paint Classification:** LBP

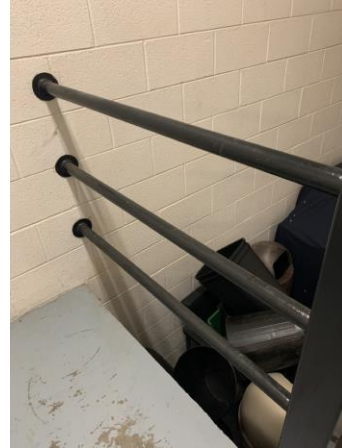
**XRF Reading:** 56  
**Component:** Stair Hand Rail  
**Substrate:** Steel  
**Paint Coating Condition:** Intact  
**Color:** Black  
**Description of Sample Location:** Lower Level North  
**Below Reportable Limit:** no  
**XRF Result (mg/cm<sup>2</sup>):** 4.6  
**Paint Classification:** **LBP**

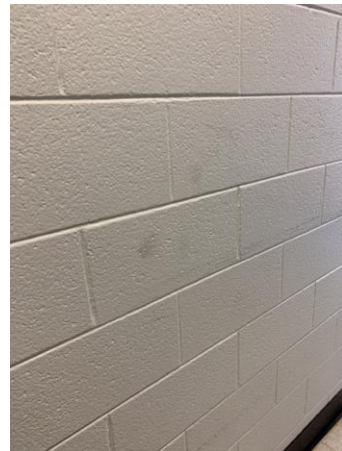
**XRF Reading:** 57  
**Component:** Wall  
**Substrate:** CMU  
**Paint Coating Condition:** Intact  
**Color:** White  
**Sample Location:** Upper Level North  
**Below Reportable Limit:** yes  
**XRF Result (mg/cm<sup>2</sup>):** ND

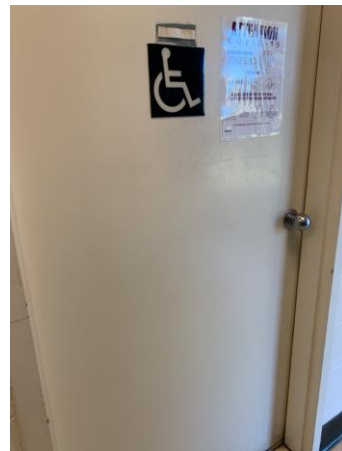
**XRF Reading:** 58  
**Component:** Door  
**Substrate:** Metal  
**Paint Coating Condition:** Intact  
**Color:** White  
**Description of Sample Location:** Upper Section North  
**Below Reportable Limit:** yes  
**XRF Result (mg/cm<sup>2</sup>):** ND

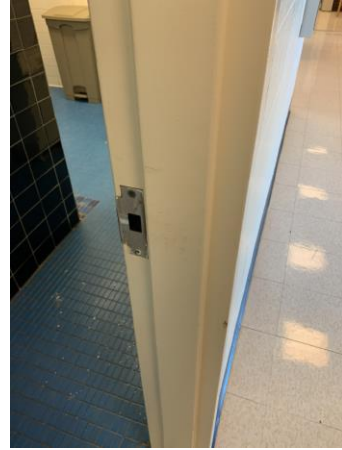
**XRF Reading:** 59  
**Component:** Door Jamb  
**Substrate:** Metal  
**Paint Coating Condition:** Intact  
**Color:** White  
**Sample Location:** Upper Level North  
**Below Reportable Limit:** yes  
**XRF Result (mg/cm<sup>2</sup>):** ND

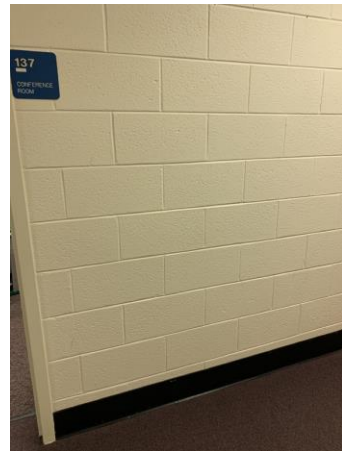
**XRF Reading:** 60  
**Component:** Wall  
**Substrate:** CMU  
**Paint Coating Condition:** Intact  
**Color:** White  
**Sample Location:** Upper Level North  
**Below Reportable Limit:** yes  
**XRF Result (mg/cm<sup>2</sup>):** ND

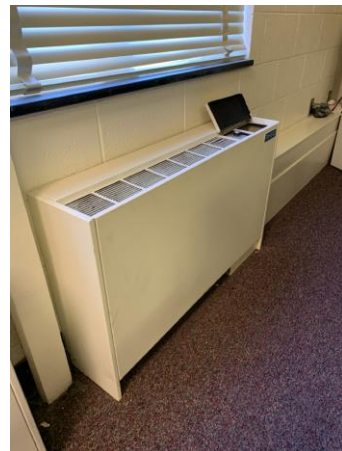
**XRF Reading:** 61  
**Component:** Unit Ventilator  
**Substrate:** Metal  
**Paint Coating Condition:** Intact  
**Color:** White  
**Sample Location:** Upper Level North  
**Below Reportable Limit:** yes  
**XRF Result (mg/cm<sup>2</sup>):** ND

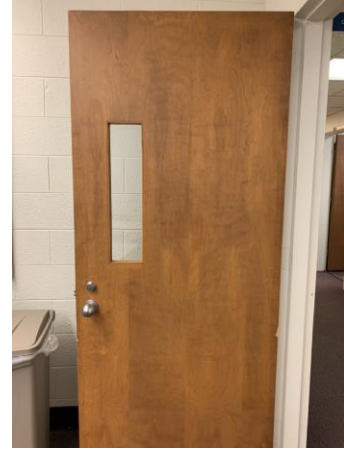
**XRF Reading:** 62  
**Component:** Door  
**Substrate:** Wood  
**Paint Coating Condition:** Intact  
**Color:** Varnish  
**Sample Location:** Upper Level North  
**Below Reportable Limit:** yes  
**XRF Result (mg/cm<sup>2</sup>):** ND

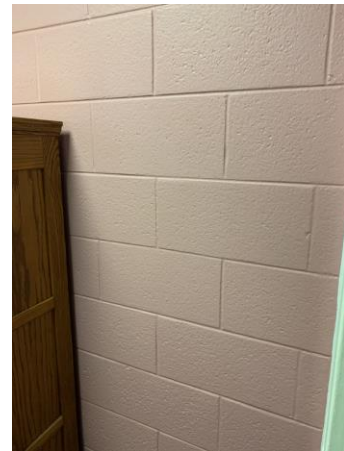
**XRF Reading:** 63  
**Component:** Wall  
**Substrate:** CMU  
**Paint Coating Condition:** Intact  
**Color:** Pink  
**Sample Location:** Upper Level North  
**Below Reportable Limit:** no  
**XRF Result (mg/cm<sup>2</sup>):** 0.22  
**Paint Classification:** LCP

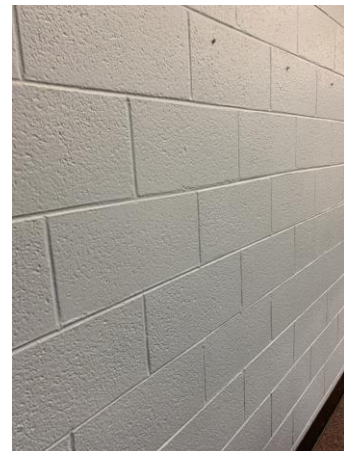
**XRF Reading:** 64  
**Component:** Wall  
**Substrate:** CMU  
**Paint Coating Condition:** Intact  
**Color:** Blue  
**Sample Location:** Upper Level North  
**Below Reportable Limit:** yes  
**XRF Result (mg/cm<sup>2</sup>):** ND

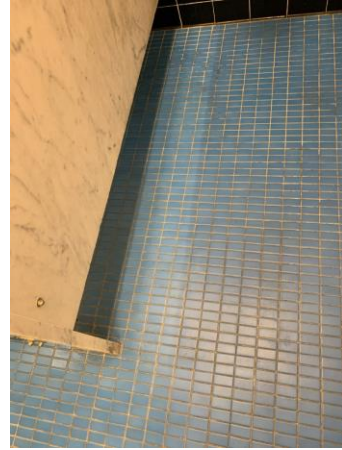
**XRF Reading:** 65  
**Component:** Floor  
**Substrate:** Ceramic Tile  
**Glaze Coating Condition:** Intact  
**Color:** Blue  
**Sample Location:** Upper Level North Restroom  
**Below Reportable Limit:** yes  
**XRF Result (mg/cm<sup>2</sup>):** ND

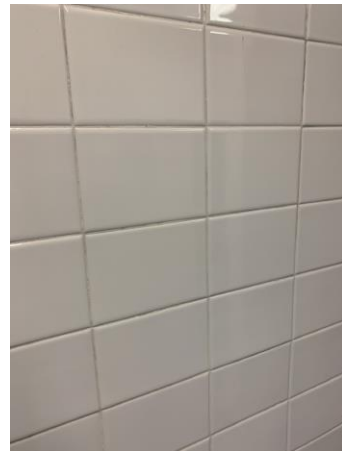
**XRF Reading:** 66  
**Component:** Wall  
**Substrate:** Ceramic Tile  
**Glaze Coating Condition:** Intact  
**Color:** White  
**Description of Sample Location:** Upper Level North Restroom  
**Below Reportable Limit:** no  
**XRF Result (mg/cm<sup>2</sup>):** 0.015  
**Glaze Classification:** LCP

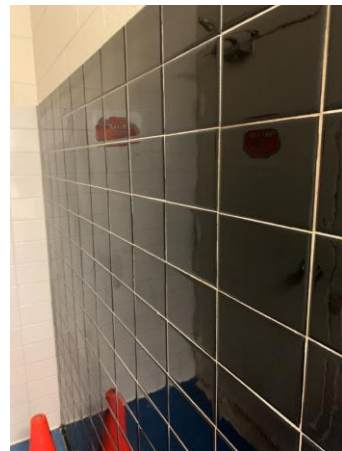
**XRF Reading:** 67  
**Component:** Wall  
**Substrate:** Ceramic Tile  
**Glaze Coating Condition:** Intact  
**Color:** Black  
**Sample Location:** Upper Level North Restroom  
**Below Reportable Limit:** no  
**XRF Result (mg/cm<sup>2</sup>):** 5.0  
**Glaze Classification:** LBP

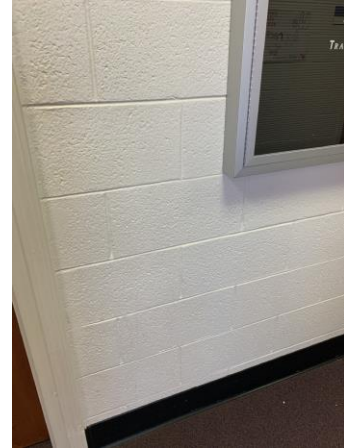
**XRF Reading:** 68  
**Component:** Wall  
**Substrate:** CMU  
**Paint Coating Condition:** Intact  
**Color:** White  
**Sample Location:** Upper Level South  
**Below Reportable Limit:** yes  
**XRF Result (mg/cm<sup>2</sup>):** ND

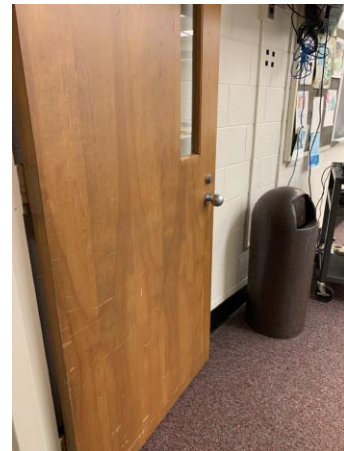
**XRF Reading:** 69  
**Component:** Door  
**Substrate:** Wood  
**Paint Coating Condition:** Intact  
**Color:** Varnish  
**Sample Location:** Upper Level South  
**Below Reportable Limit:** yes  
**XRF Result (mg/cm<sup>2</sup>):** ND

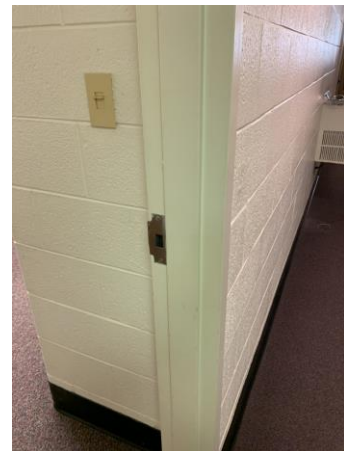
**XRF Reading:** 70  
**Component:** Door Jamb  
**Substrate:** Metal  
**Paint Coating Condition:** Intact  
**Color:** White  
**Sample Location:** Upper Level South  
**Below Reportable Limit:** no  
**XRF Result (mg/cm<sup>2</sup>):** 0.019  
**Paint Classification:** LCP

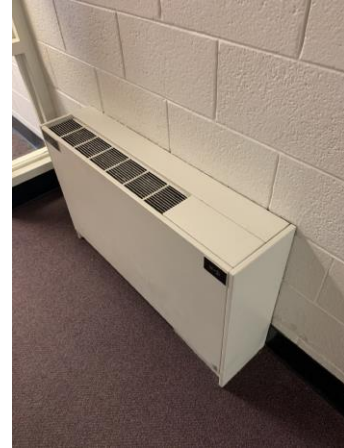
**XRF Reading:** 71  
**Component:** Unit Ventilator  
**Substrate:** Metal  
**Paint Coating Condition:** Intact  
**Color:** White  
**Sample Location:** Upper Level South  
**Below Reportable Limit:** yes  
**XRF Result (mg/cm<sup>2</sup>):** ND

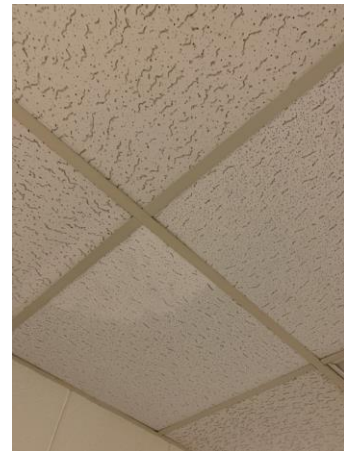
**XRF Reading:** 72  
**Component:** Ceiling Grid  
**Substrate:** Metal  
**Paint Coating Condition:** Intact  
**Color:** Tan  
**Description of Sample Location:** Upper Level South  
**Below Reportable Limit:** yes  
**XRF Result (mg/cm<sup>2</sup>):** ND

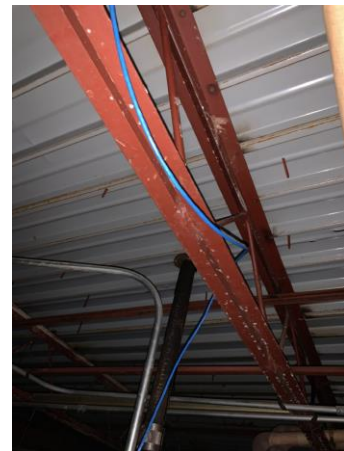
**XRF Reading:** 73  
**Component:** Structural Steel Beam  
**Substrate:** Steel  
**Paint Coating Condition:** Intact  
**Color:** Red  
**Sample Location:** Upper Level North  
**Below Reportable Limit:** no  
**XRF Result (mg/cm<sup>2</sup>):** 0.008  
**Paint Classification:** LCP

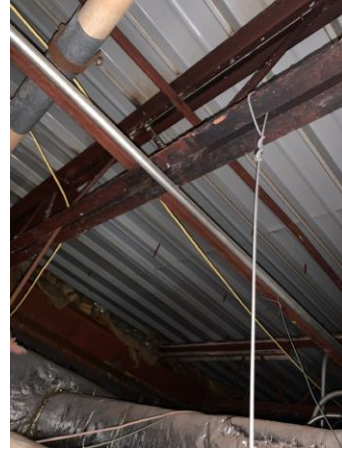
**XRF Reading:** 74  
**Component:** Structural Steel Beam  
**Substrate:** Steel  
**Paint Coating Condition:** Intact  
**Color:** Black  
**Description of Sample Location:** Upper Level North  
**Below Reportable Limit:** yes  
**XRF Result (mg/cm<sup>2</sup>):** ND

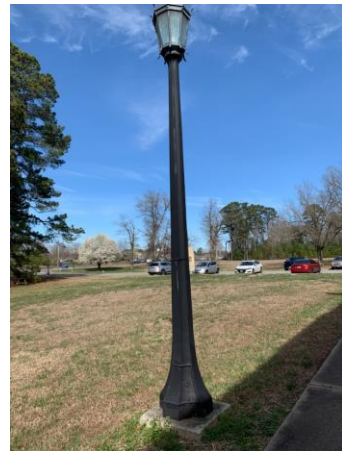
**XRF Reading:** 75  
**Component:** Exterior Lamp Post  
**Substrate:** Steel  
**Paint Coating Condition:** Intact  
**Color:** Black  
**Sample Location:** Exterior  
**Below Reportable Limit:** no  
**XRF Result (mg/cm<sup>2</sup>):** 3.9  
**Paint Classification:** **LBP**

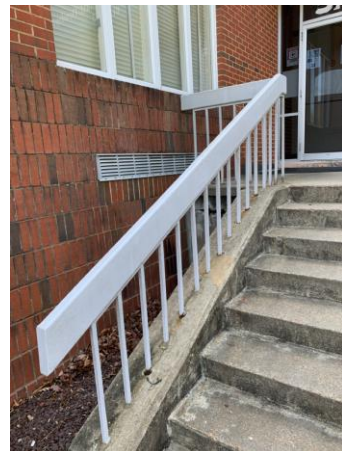
**XRF Reading:** 76  
**Component:** Exterior Stair Railing  
**Substrate:** Steel  
**Paint Coating Condition:** Intact  
**Color:** White  
**Sample Location:** Exterior  
**Below Reportable Limit:** no  
**XRF Result (mg/cm<sup>2</sup>):** 0.45  
**Paint Classification:** **LCP**

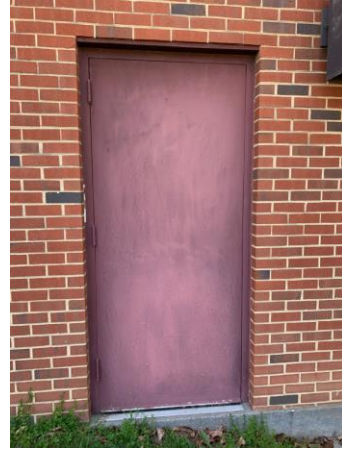
**XRF Reading:** 77  
**Component:** Door Exterior Side  
**Substrate:** Metal  
**Paint Coating Condition:** Fair  
**Color:** Red  
**Sample Location:** Exterior  
**Below Reportable Limit:** yes  
**XRF Result (mg/cm<sup>2</sup>):** ND

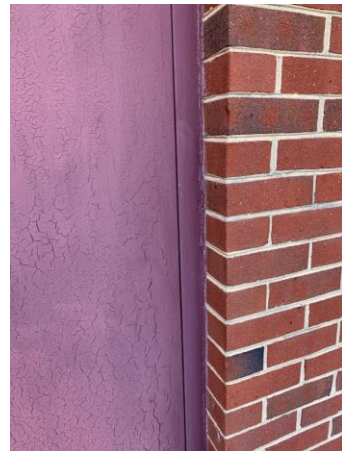
**XRF Reading:** 78  
**Component:** Exterior Side Door Frame  
**Substrate:** Metal  
**Paint Coating Condition:** Fair  
**Color:** Red  
**Description of Sample Location:** Exterior  
**Below Reportable Limit:** no  
**XRF Result (mg/cm<sup>2</sup>):** 0.025  
**Paint Classification:** LCP

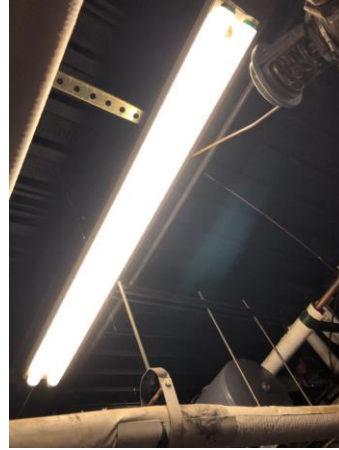
**Area:** Boiler Area  
**Description:** Potential Heavy Metal Containing Devices:  
Fluorescent Light Tubes (potential mercury)  
**Quantity:** 8  
**Notes:** 4 Associated ballasts (Potential PCBs)

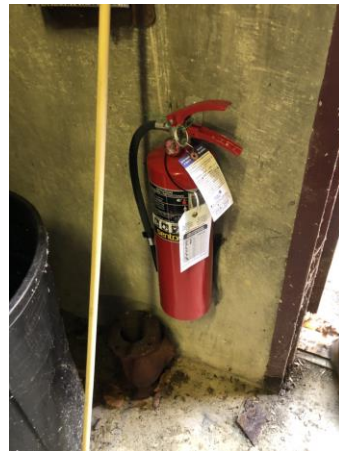
**Area:** Boiler Area  
**Description:** Potential Refrigerant Containing Devices:  
Fire Extinguisher  
**Quantity:** 1  
**Notes:** N/A

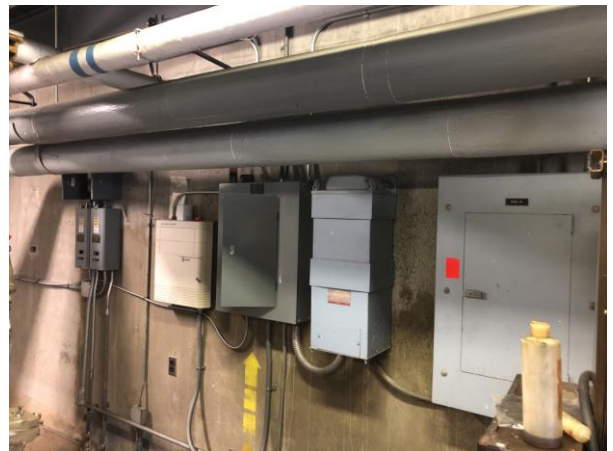
**Area:** Boiler Area  
**Description:** Miscellaneous Electrical Components  
**Quantity:** 15  
**Notes:** N/A

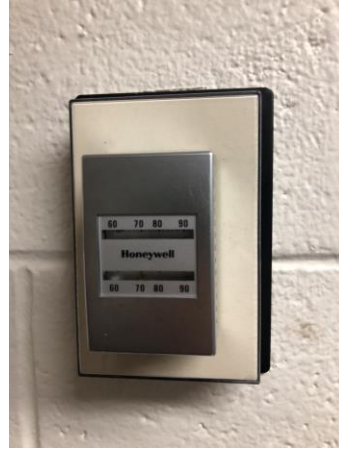
**Area:** Boiler Area  
**Description:** Potential Heavy Metal Containing Device:  
Thermostat (potential mercury)  
**Quantity:** 1  
**Notes:** N/A

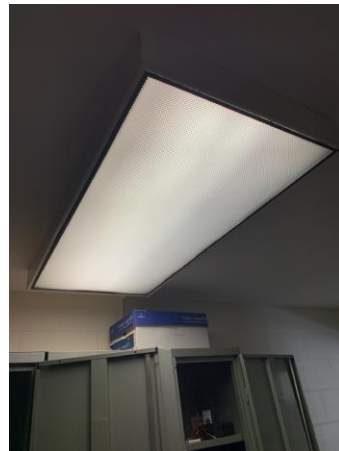
**Area:** Lower Level  
**Description:** Potential Heavy Metal Containing Devices:  
Fluorescent Light Tubes (potential mercury)  
**Quantity:** 166  
**Notes:** 83 associated ballasts (potential PCBs)

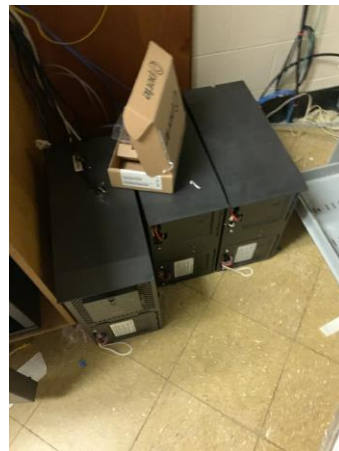
**Area:** Lower Level  
**Description:** Potential Heavy Metal Containing Devices:  
Miscellaneous Computer Equipment  
**Quantity:** 15  
**Notes:** N/A

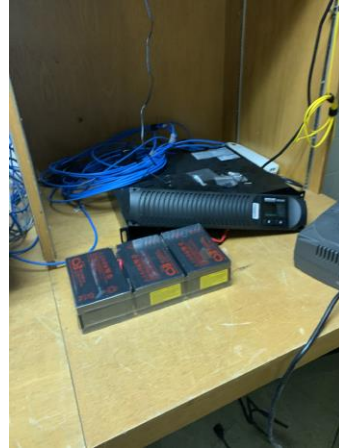
**Area:** Lower Level  
**Description:** Potential Heavy Metal Containing Devices:  
 Miscellaneous Battery Packs  
**Quantity:** 20  
**Notes:** N/A

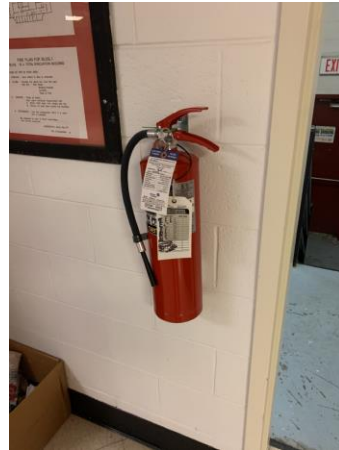
**Area:** Lower Level  
**Description:** Potential Refrigerant Containing Devices:  
 Fire Extinguishers  
**Quantity:** 2  
**Notes:** N/A

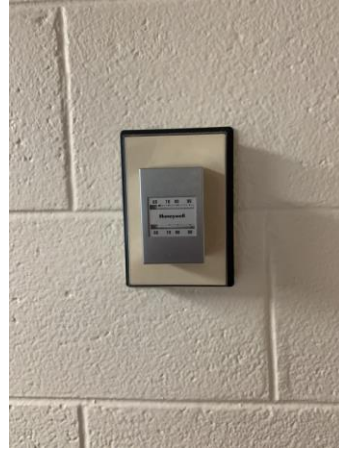
**Area:** Lower Level  
**Description:** Potential Heavy Metal Containing Devices:  
Thermostats (potential mercury)  
**Quantity:** 9  
**Notes:** N/A

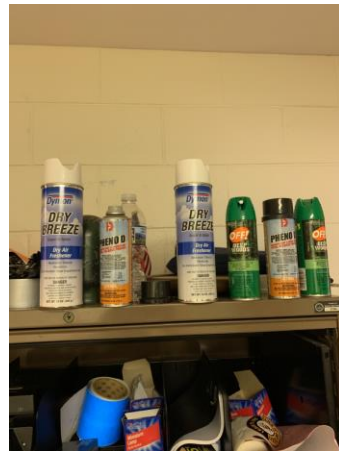
**Area:** Lower Level  
**Description:** Miscellaneous Aerosols  
**Quantity:** 25 Cans  
**Notes:** N/A

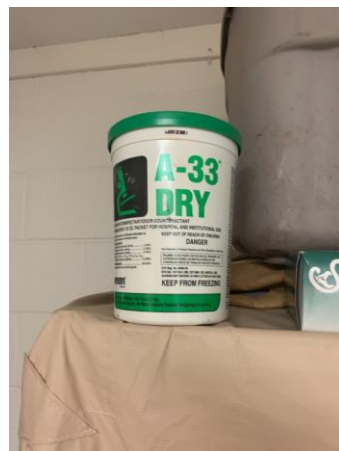
**Area:** Lower Level  
**Description:** Miscellaneous Cleaning Supplies  
**Quantity:** 9 Containers  
**Notes:** N/A

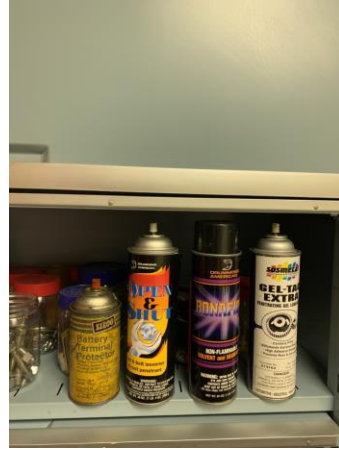
**Area:** Lower Level  
**Description:** Miscellaneous Solvents  
**Quantity:** 4 Spray Cans  
**Notes:** N/A

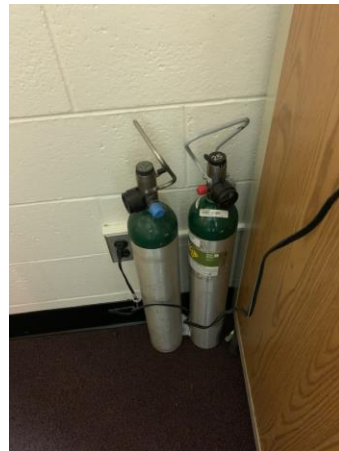
**Area:** Lower Level  
**Description:** Compressed Gas Cylinders: Oxygen  
**Quantity:** 4 Cylinders  
**Notes:** N/A

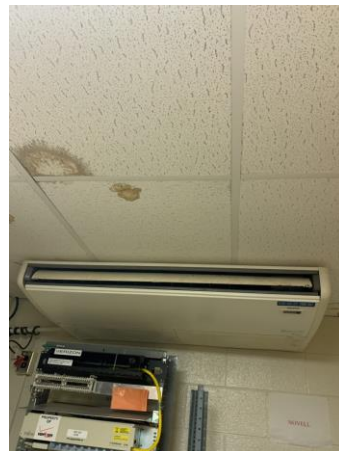
**Area:** Lower Level  
**Description:** Potential Refrigerant Containing Devices:  
Air Conditioner  
**Quantity:** 1  
**Notes:** N/A

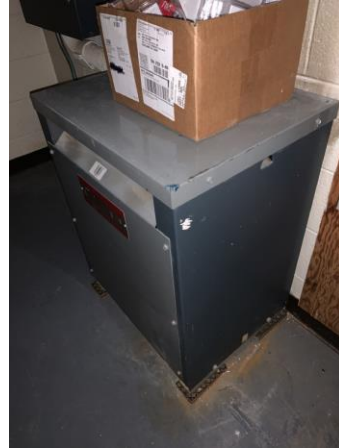
**Area:** Lower Level  
**Description:** Potential PCB Containing Devices: Transformer  
**Quantity:** 1  
**Notes:** N/A

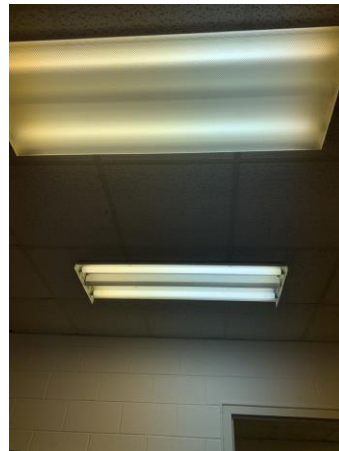
**Area:** Upper Level  
**Description:** Potential Heavy Metal Containing Devices:  
 Fluorescent Light Tubes (potential mercury)  
**Quantity:** 560  
**Notes:** N/A

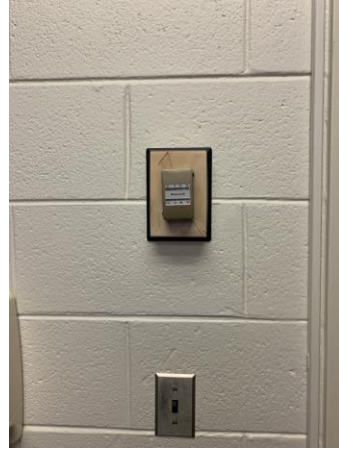
**Area:** Upper Level  
**Description:** Potential Heavy Metal Containing Devices:  
Thermostats (potential mercury)  
**Quantity:** 30  
**Notes:** N/A

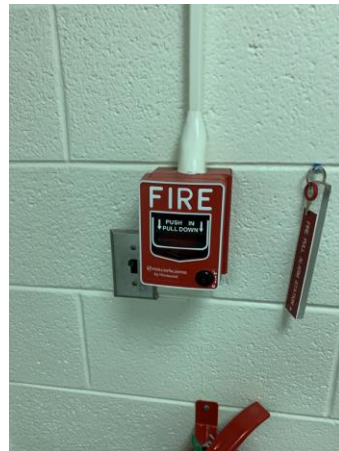
**Area:** Upper and Lower Levels  
**Description:** Potential Heavy Metal Containing Devices:  
Security System and Alarm Batteries (potential mercury)  
**Quantity:** 6  
**Notes:** N/A

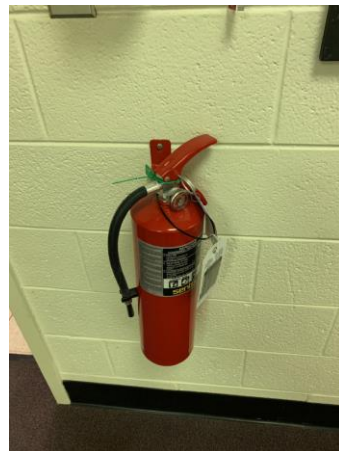
**Area:** Upper Level  
**Description:** Potential Refrigerants Containing Devices:  
Fire Extinguishers  
**Quantity:** 7  
**Notes:** N/A

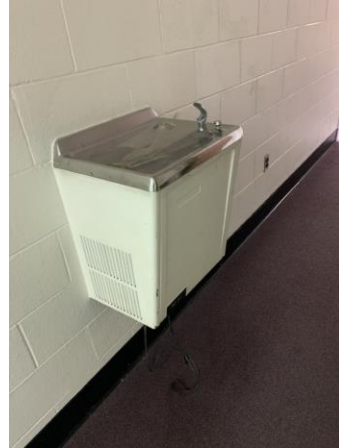
**Area:** Upper Level  
**Description:** Potential Refrigerant Containing Devices:  
Water Fountains  
**Quantity:** 2  
**Notes:** N/A

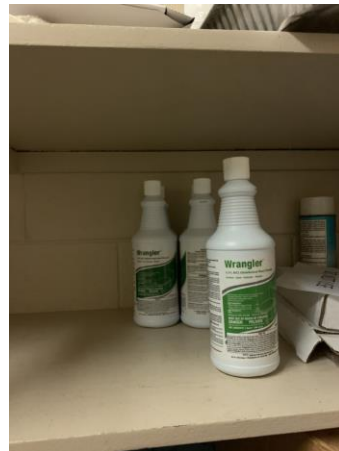
**Area:** Upper Level  
**Description:** Miscellaneous Disinfectants  
**Quantity:** 6 Bottles  
**Notes:** N/A

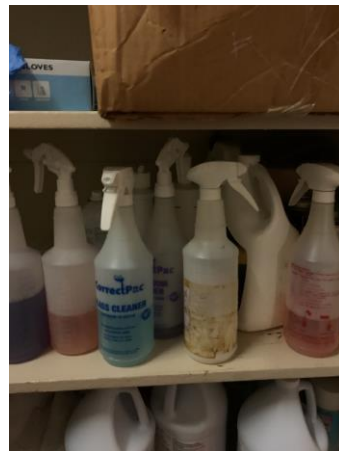
**Area:** Upper Level  
**Description:** Miscellaneous Cleaning Supplies  
**Quantity:** 25 Bottles  
**Notes:** N/A

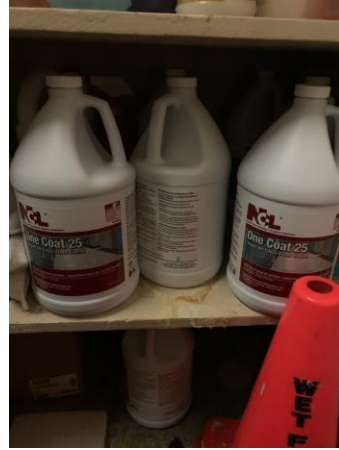
**Area:** Upper Level  
**Description:** Miscellaneous Floor Wax  
**Quantity:** 5 Gallons  
**Notes:** N/A

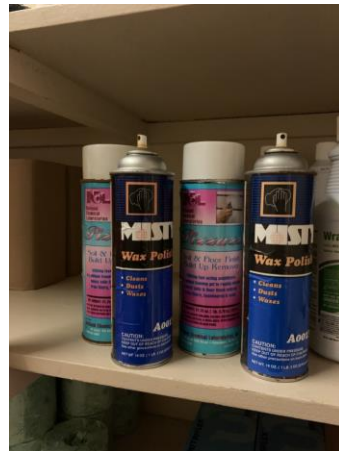
**Area:** Upper Level  
**Description:** Miscellaneous Aerosols  
**Quantity:** 6 Spray Cans  
**Notes:** N/A

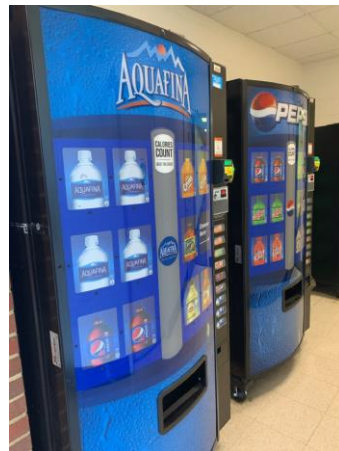
**Area:** Upper Level  
**Description:** Potential Refrigerant Containing Devices:  
Retail Floor Coolers  
**Quantity:** 2  
**Notes:** N/A

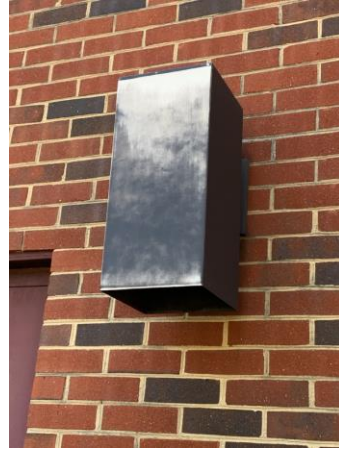
**Area:** Building Exterior  
**Description:** Potential Heavy Metal Containing Devices:  
HID Lamps  
**Quantity:** 10  
**Notes:** N/A

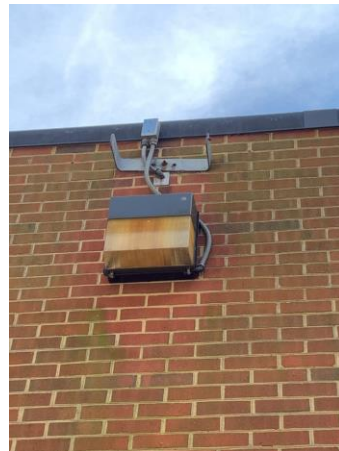
**Area:** Building Exterior  
**Description:** Potential Heavy Metal Containing Devices:  
Emergency Lighting System Batteries  
**Quantity:** 5  
**Notes:** N/A

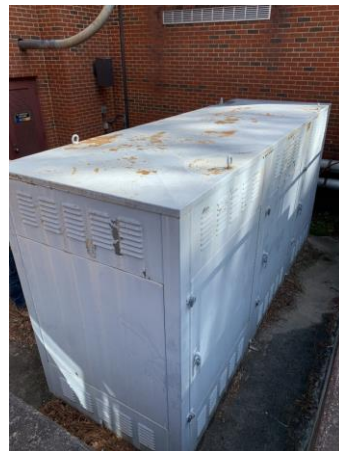
**Area:** Building Exterior  
**Description:** Potential PCB Containing Devices:  
Transformer  
**Quantity:** 1  
**Notes:** N/A

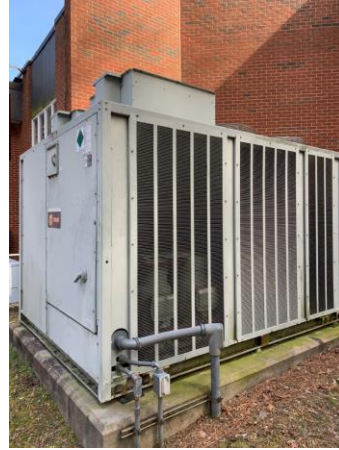
**Area:** Building Exterior

**Description:** Potential Refrigerants Containing Devices:  
Air Conditioner

**Quantity:** 1

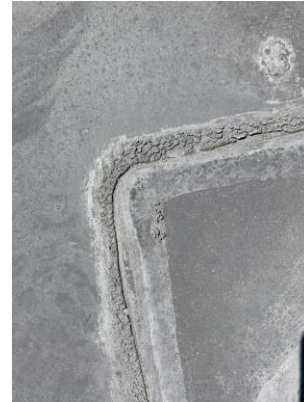
**Sample Number:** PCB-1  
**Material Location:** Exterior  
**Material Description:** Black Roof Seam Sealant  
**Substrate Adjacent to Material:** Roof membrane  
**Ground Cover Below Material:** Soil  
**Reporting Limit (mg/kg): 0.96**  
**Result (mg/kg):**  
 Aroclor 1016 – ND  
 Aroclor 1221 – ND  
 Aroclor 1232 – ND  
 Aroclor 1242 – ND  
 Aroclor 1248 – ND  
 Aroclor 1254 – ND  
 Aroclor 1260 – ND  
 Aroclor 1262 – ND  
 Aroclor 1268 – ND

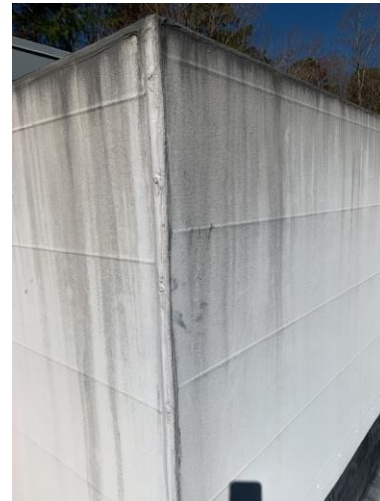
**Sample Number:** PCB-2  
**Material Location:** Exterior  
**Material Description:** White Roof Unit Sealant  
**Substrate Adjacent to Material:** Roof Membrane  
**Ground Cover Below Material:** Soil  
**Reporting Limit (mg/kg):**  
**Result (mg/kg): 0.25**  
 Aroclor 1016 – ND  
 Aroclor 1221 – ND  
 Aroclor 1232 – ND  
 Aroclor 1242 – ND  
 Aroclor 1248 – ND  
 Aroclor 1254 – 1.4  
 Aroclor 1260 – ND  
 Aroclor 1262 – ND  
 Aroclor 1268 – ND

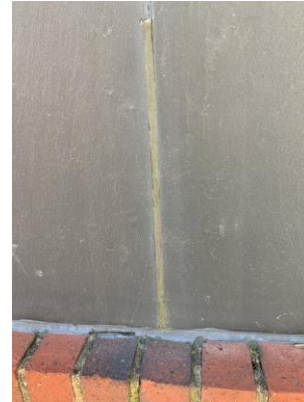
**Sample Number:** PCB-3  
**Material Location:** Exterior  
**Material Description:** Exterior Panel Caulk  
**Substrate Adjacent to Material:** Brick  
**Ground Cover Below Material:** Soil  
**Reporting Limit (mg/kg): 98**  
**Result (mg/kg):**  
 Aroclor 1016 – ND  
 Aroclor 1221 – ND  
 Aroclor 1232 – ND  
 Aroclor 1242 – ND  
 Aroclor 1248 – ND  
 Aroclor 1254 – **620**  
 Aroclor 1260 – ND  
 Aroclor 1262 – ND  
 Aroclor 1268 – ND
