# **HAZARDOUS MATERIALS SURVEY REPORT**

## **Eastern State Hospital Building 3**

**4601 Ironbound Rd Williamsburg Virginia 23188**

**Report Date: April 18, 2023**

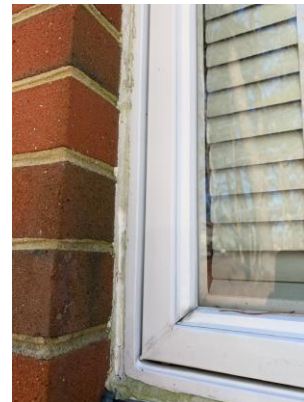
**Sample Number:** PCB-4  
**Material Location:** Exterior  
**Material Description:** Exterior Window Caulk  
**Substrate Adjacent to Material:** Brick  
**Ground Cover Below Material:** Soil  
**Reporting Limit (mg/kg): 4.9**  
**Result (mg/kg):**  
 Aroclor 1016 – ND  
 Aroclor 1221 – ND  
 Aroclor 1232 – ND  
 Aroclor 1242 – ND  
 Aroclor 1248 – ND  
 Aroclor 1254 – **19**  
 Aroclor 1260 – ND  
 Aroclor 1262 – ND  
 Aroclor 1268 – ND
